Manhole Inspection Summary

Manhole # S29M__046MH

Insp Date: **12/5/08 9:25 AM**

Location Address: **808 Carrol St.**

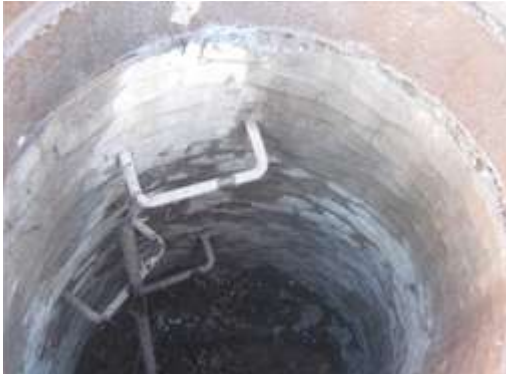
Miscellaneous

view of manhole steps

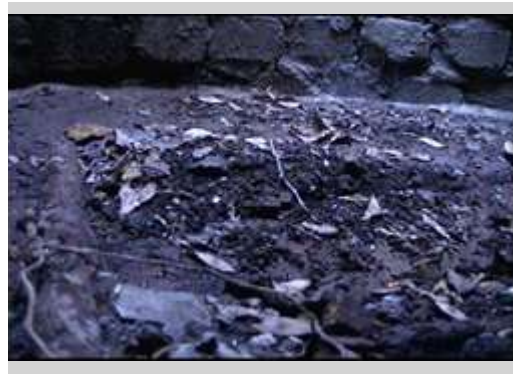
Defect 2

Condition: ☐ Sound ☐ Cracked ☐ Root Intrusion ☐ Deteriorated ☐ Leaks ☒ Debris

channel debris

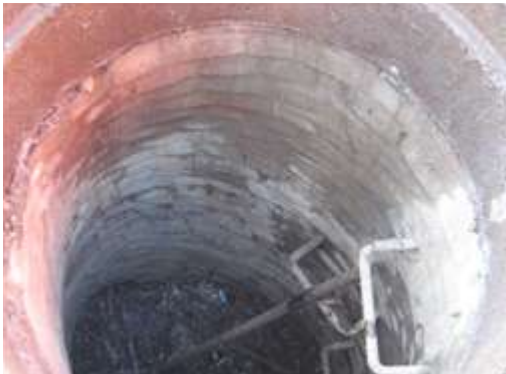
Defect 1

Infiltration: ☐ None ☐ Joint ☐ Cracks ☒ Mortar ☐ Roots ☐ Wall

Infiltration: ☐ None ☐ Joint ☐ Cracks ☐ Mortar ☐ Roots ☒ Wall

chimney and corbel infiltration

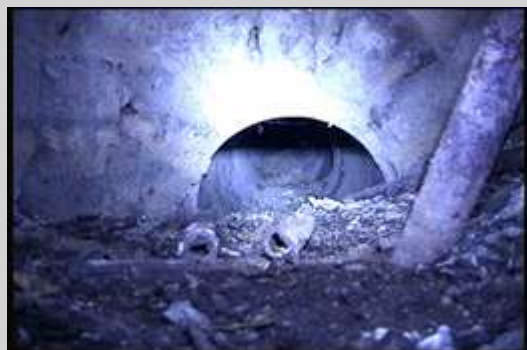
12 O'Clock Outflow

8 in. Circular Gravity Sewer
Pipe Out @ 12 O'Clock
